The information below is quoted from Diane Salkie, the EPA remedial project manager for the Ciba-Geigy Superfund site, in response to questions asked at the January 17, 2023 webinar hosted by Save Barnegat Bay.

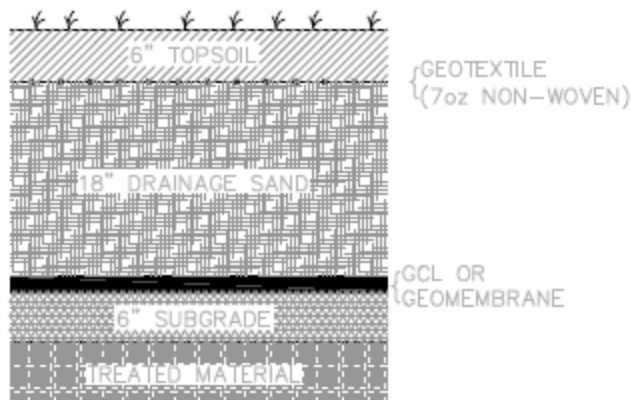
(Cap detail not to scale)

The diagram below is a cross section of the cap. The treated material is 30" below the ground surface and the geomembrane is a 40 mil HDPE. See the pdf attachments from the Remedial Action Report for OU2 for a description of the materials.

3.7.8.1 Cap Configuration

- 6-inch topsoil layer to support vegetative growth and run-off;
- geotextile filter fabric to provide separation between the topsoil and drainage layer;
- 18-inch sand layer (to provide drainage for rainfall that infiltrates);
- barrier layer to minimize infiltration (40 mil geomembrane) with a maximum permeability of 1×10^{-7} cm/sec.; and
- 6-inch sub-base material (<3/4”) to protect the barrier layer. This consisted of sand from the borrow area.
